# Marion County Courthouse Square Structural Remediation Project Summary

October 26, 2010

MARION COUNTY COURTHOUSE SQUARE & BUS MALL REMEDIATION PROJECT October 26, 2010

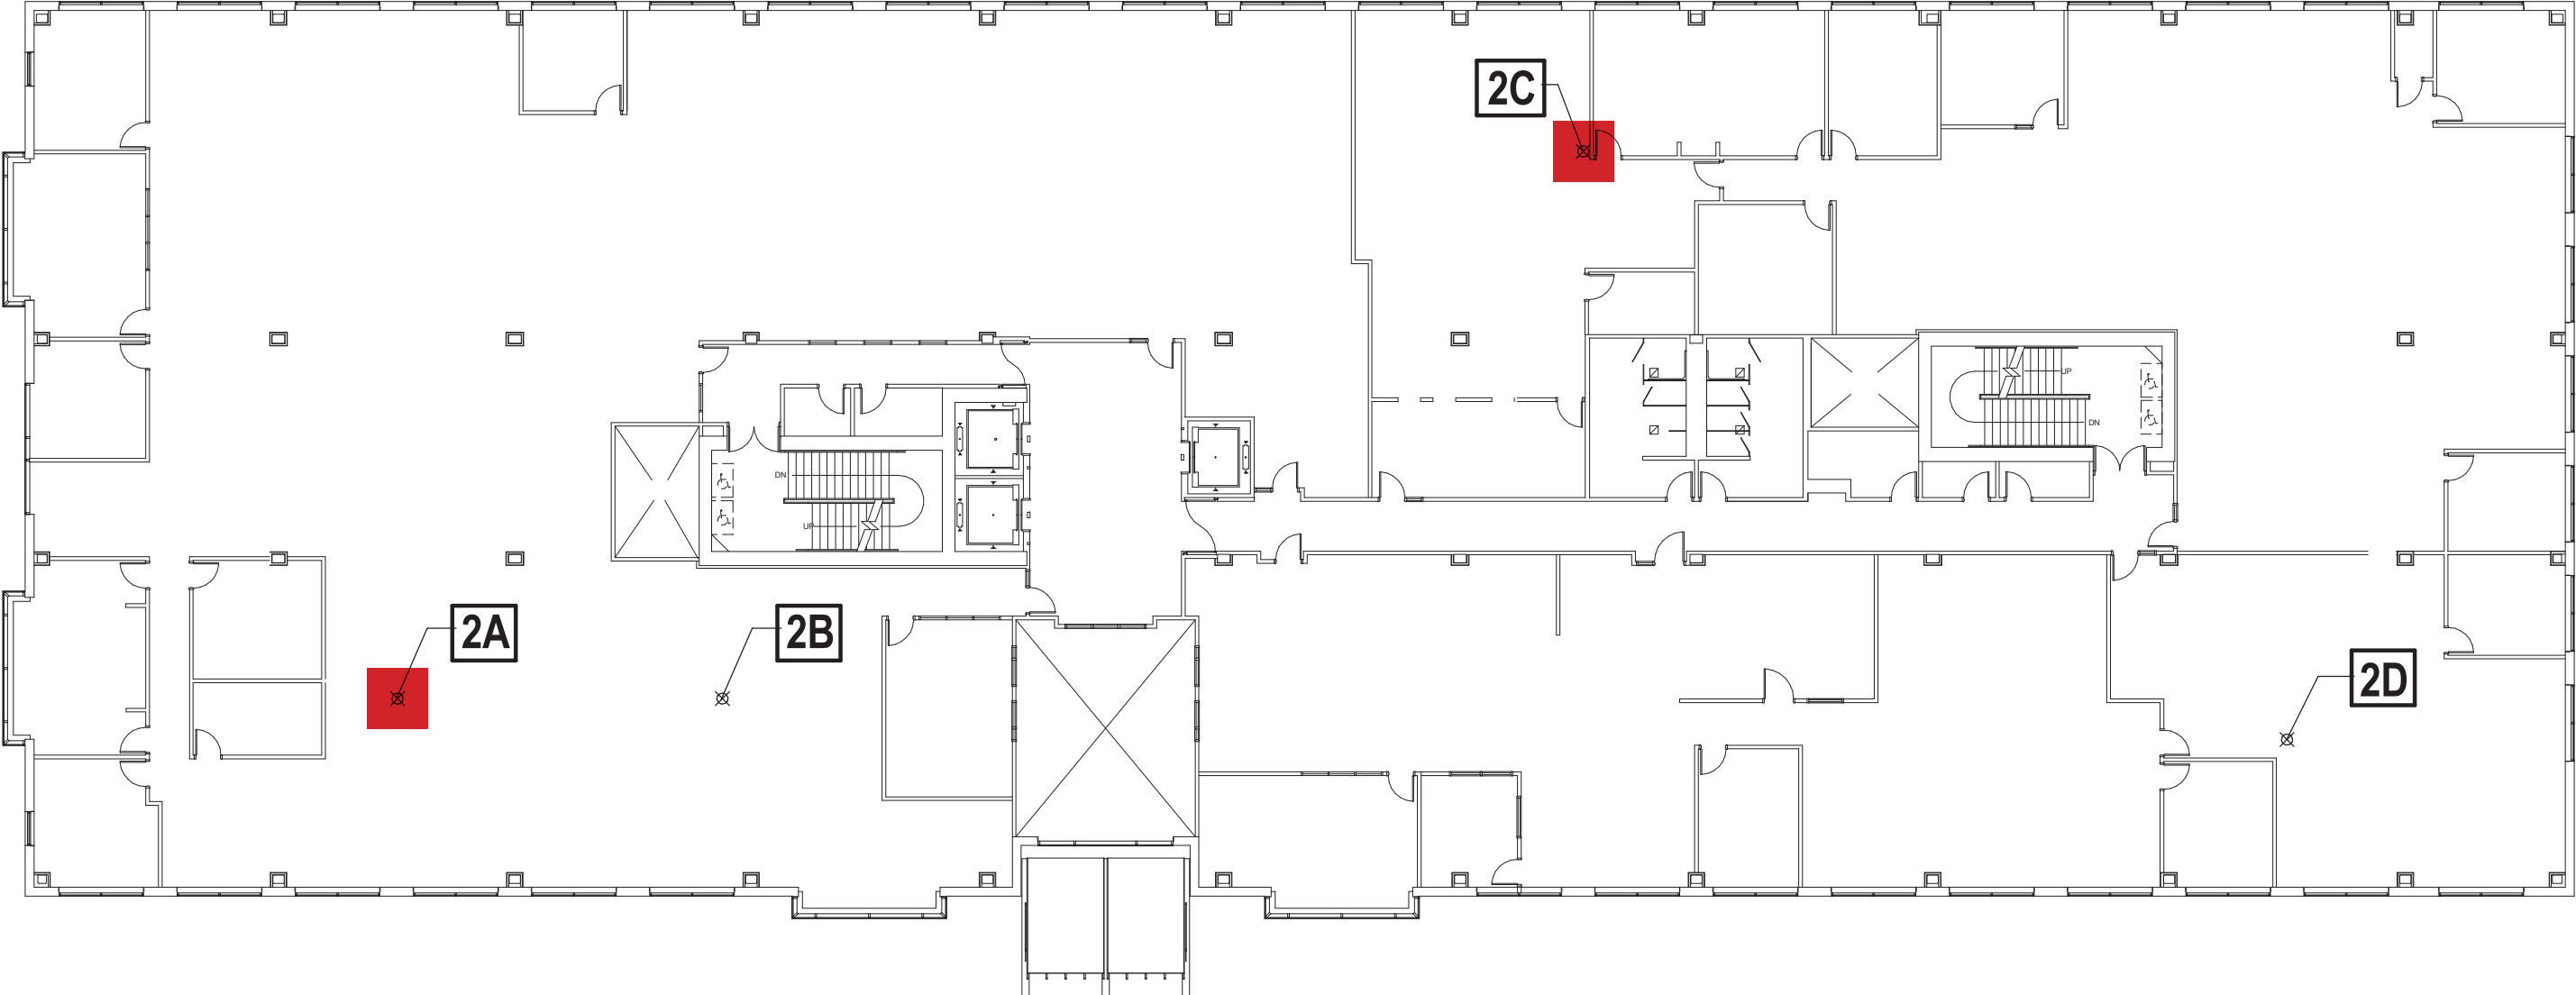
# Testing Locations - Second Floor

<b>Carlson</b>	<b>PSI</b>
Testing Locations		lbs/in <sup>2</sup> (psi)	lbs/in <sup>2</sup> (psi)
Fifth Floor	5A-2	5150	4360
	5A-3		4240
	5C-1	4520	3690
	5C-2		3680
Fourth Floor	4B-1	3730	3480
	4B-2		3810
	4C-1	4860	4020
	4C-2		4600
Third Floor	3B-1	3490	3330
	3B-2		3480
	3C-1	3800	3600
	3C-2		3620
Second Floor	2A-2	3460	3040
	2A-3		3770
	2C-1	3710	3270
	2C-2		3360

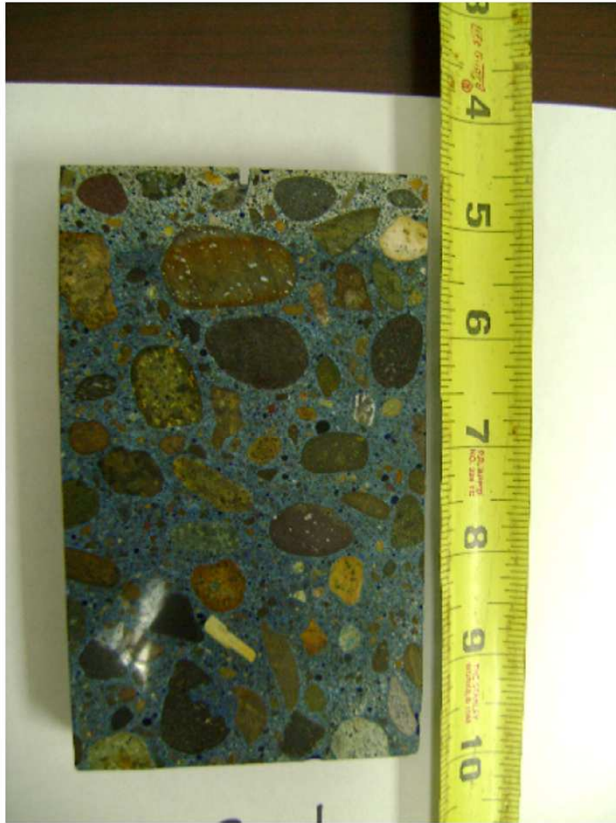
Photograph #1 - Sample 06033-1. Change in paste color can be seen at top surface and lower right corner.

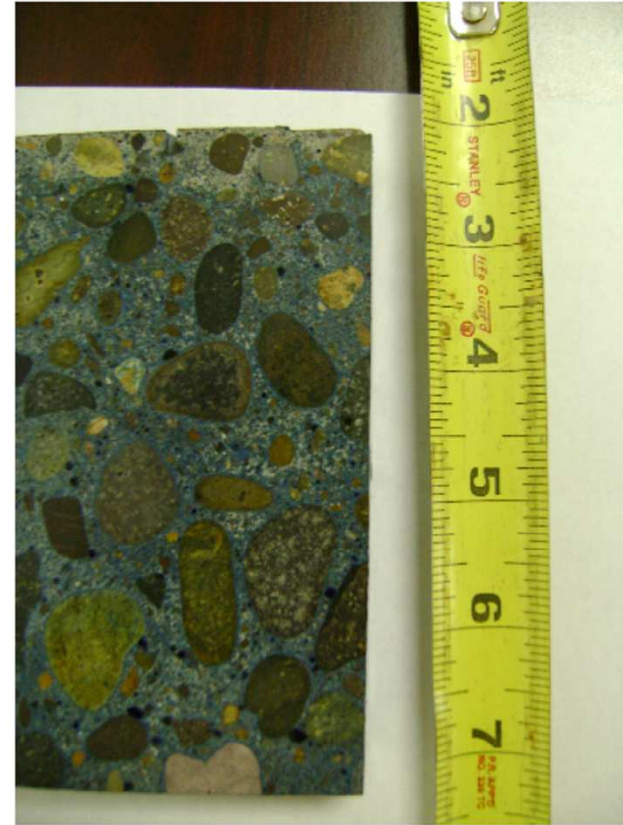
Photograph #2 - Sample 06033-2. Color change can be seen in paste at top surface as well as the bulk paste.
