BOARD OF COMMISSIONERS

MINUTES OF THE BOARD SESSION – Regular Session

2. Accept final closeout report for the Juvenile Court addition and Transition Center roof replacement project. – Kevin Burton and Larry Tilford

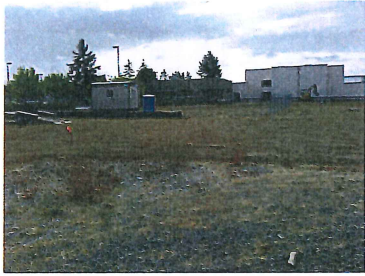
Exterior progress
Construction trailer and fencing arrives on site

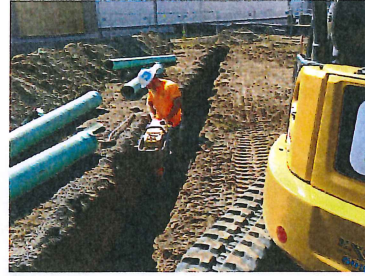
Exterior progress
Storm drain piping is being installed

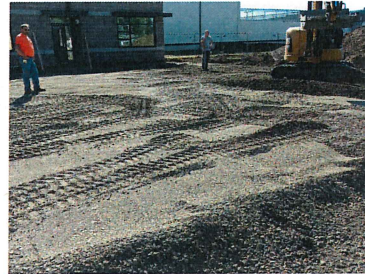
Exterior progress
Final gravel placement for concrete pad

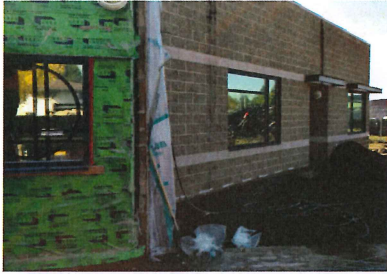
The 2 windows on the left will remain, the alcove where the light is will become the passage between the old and new staff areas and the far window gets removed and infilled.

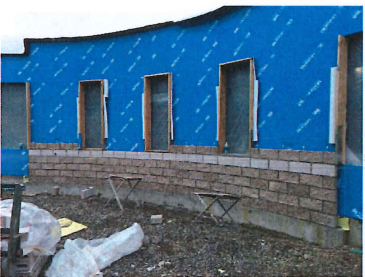
Exterior progress
CMU and vapor barrier in progress-note roofing material hanging over parapet wall

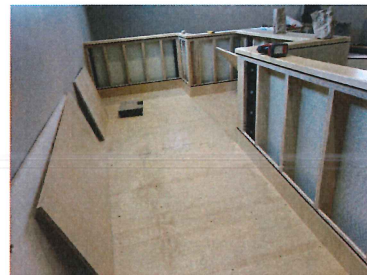
Interior progress
Note the ballistic armor inside the walls of Judge's bench and removable panels for electrical access

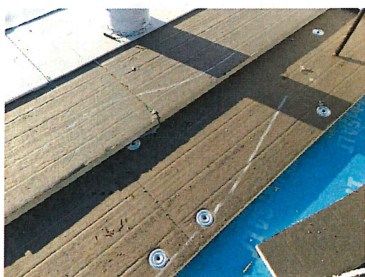
Phase 1
Display of roof system layers-Vapor barrier (blue), first layer of 2" insulation mechanically fastened, second layer of 2" insulation adhered with adhesive, cover board and roof membrane fully adhered

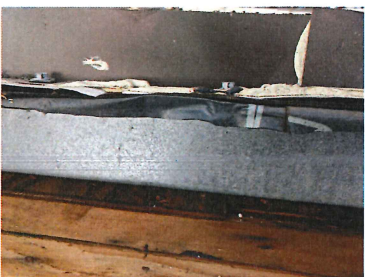
Phase 1
Wet plywood at the top of the wall
All along the top of wall above low slope roof had signs of water infiltration which had a path under the roof and vapor barrier

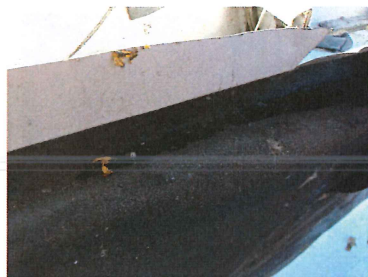
Phase 1
Moisture pooling on vapor barrier at top of wall

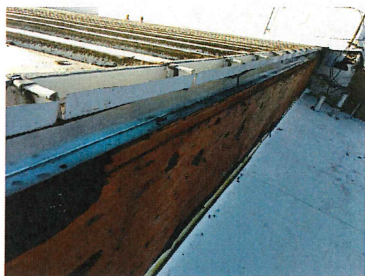
Phase 1
Wet plywood and water pooling in the flashing

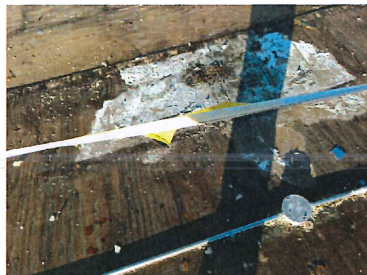
Phase 2
Rotted plywood found during demo

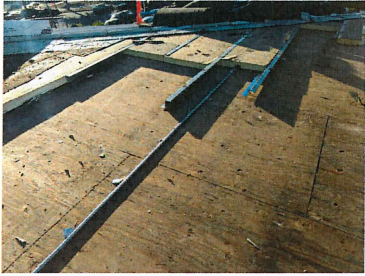
- In 2015, two forensic roofing companies hired to study the roofing, discovered there was no vapor barrier:
 - As warm air rose to the roof level, it would condensate and drip; and

Phase 2
Old roof demo-no visible vapor barrier was present

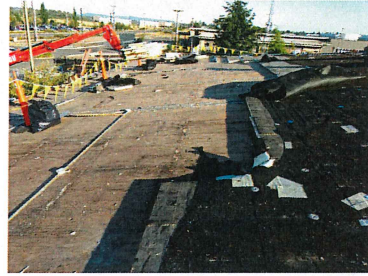
Phase 2
Demo of old roof system. No structural plywood, only 30 pound roofing felt, no self sealing vapor barrier over electrical conduits, no cover board and thinner insulation is what was found

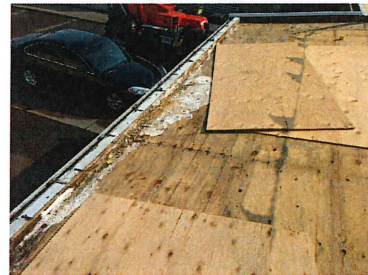
Phase 2
Rotted insulation curb block and plywood decking

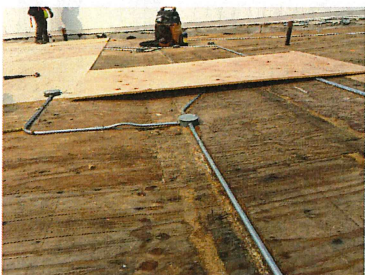
Valley caused by rafters on uphill side of mid-beam not following the roof plane

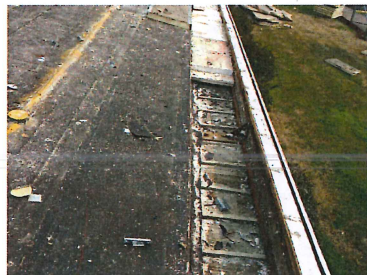
Phase 2
Demo of old roof exposing soffit being filled with insulating foam and no structural wood
